RE: Update on Algae Presence in North and South Lagoons

Exhibit A – Photo Log of Algae in North and South Lagoons

Client's Name: Bel Marin Keys Community Services District	Site Location: BMKCSD: North and South Lagoons	Project No. 0020B046.00
---	--	-----------------------------------

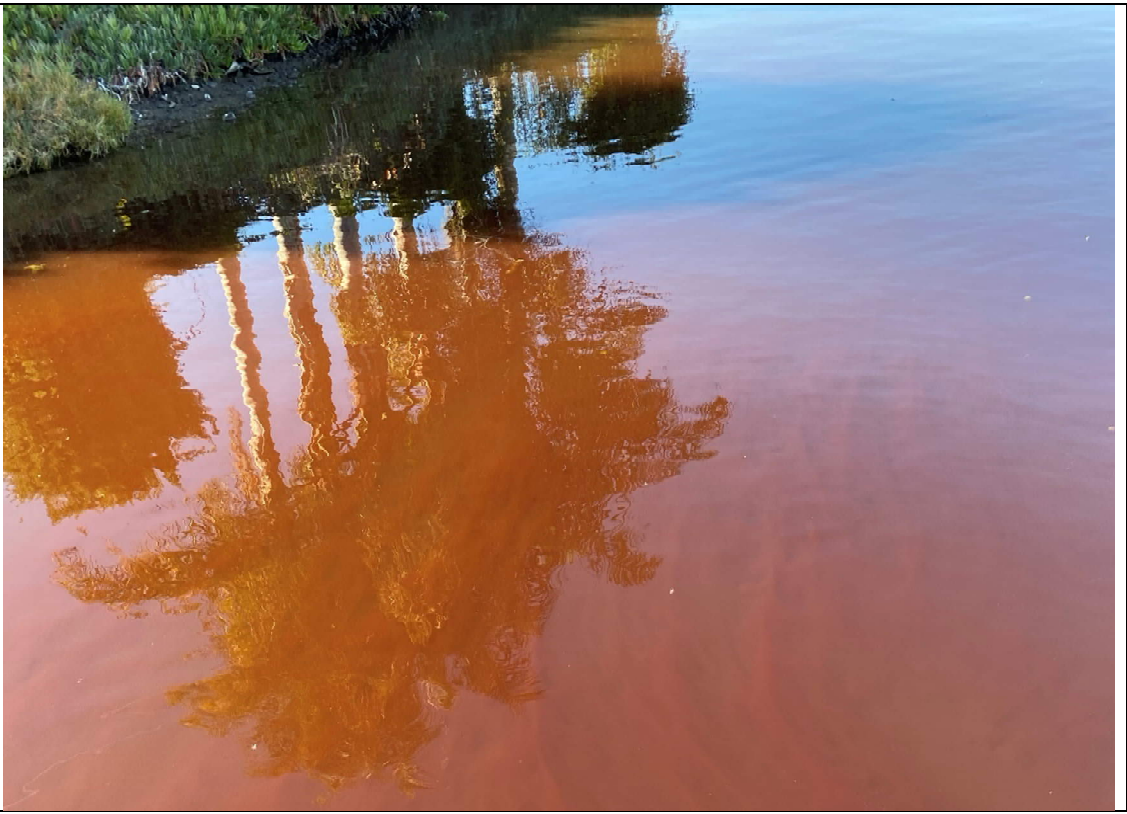
Photo No. 1	Date: 11/30/2020
Direction Photo Taken: N/A	
Photo Taken By: A. Cormier	
Description: North Lagoon adjacent to the Gardens Dock.

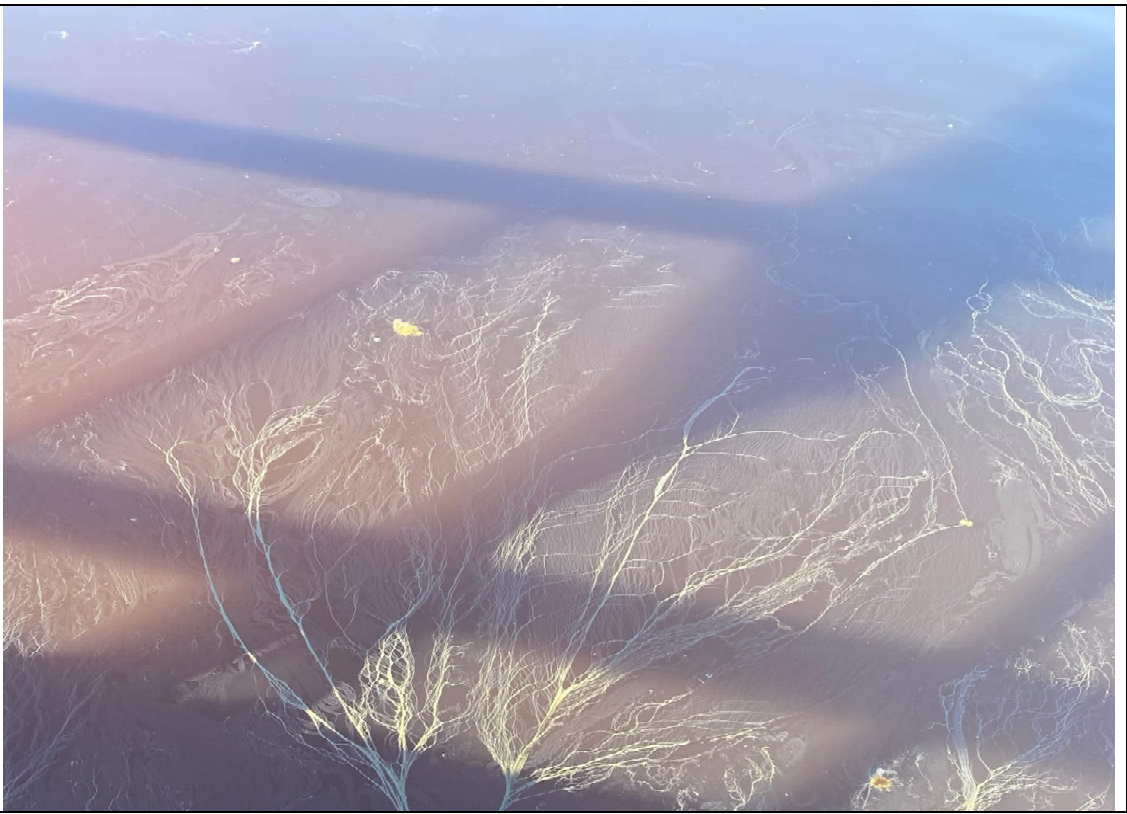
Photo No. 2	Date: 11/30/2020
Direction Photo Taken: N/A	
Photo Taken By: A. Cormier	
Description: North Lagoon adjacent to 109 Caribe.

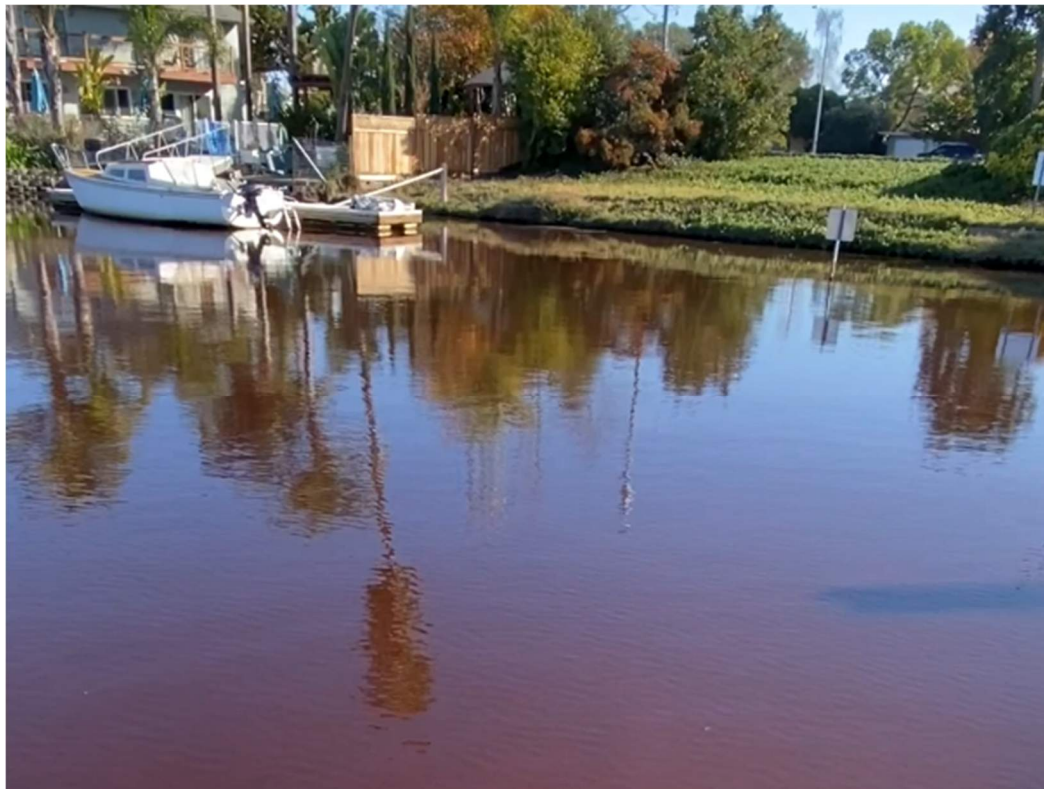
Photo No. 3	Date: 11/30/2020
Direction Photo Taken: Southeast	
Photo Taken By: A. Cormier	
Description: North Lagoon adjacent to the Gardens Dock

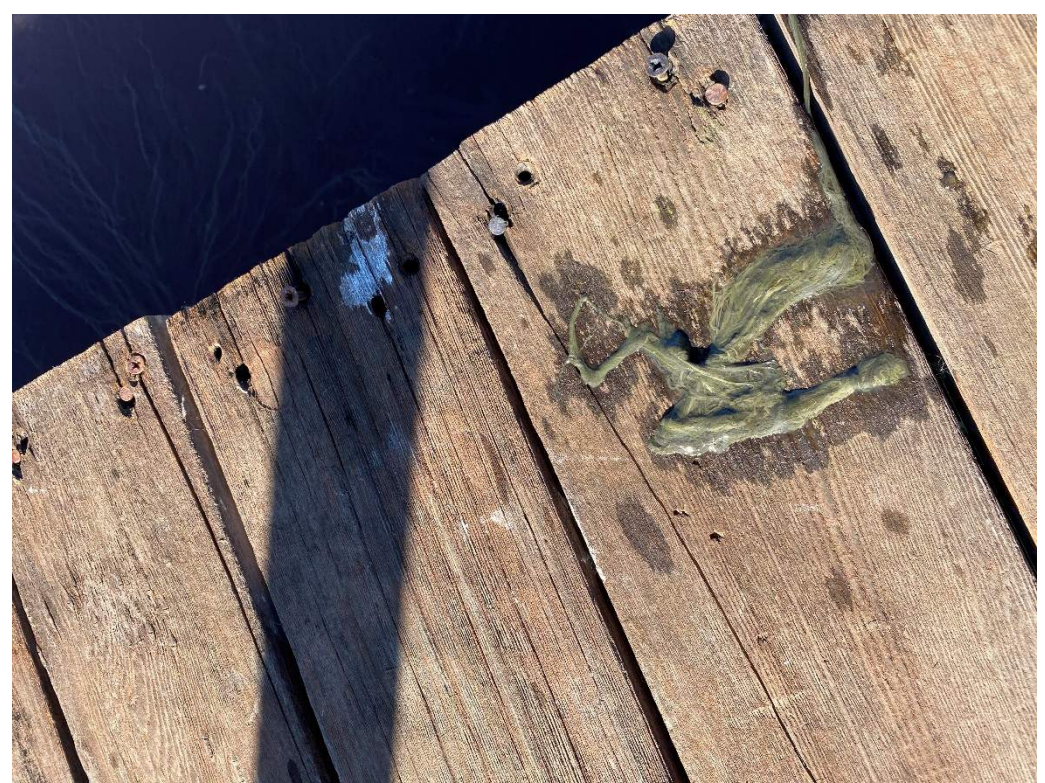
Photo No. 4	Date: 11/30/2020
Direction Photo Taken: N/A	
Photo Taken By: A. Cormier	
Description: Physical sample of the algae removed from the North Lagoon.

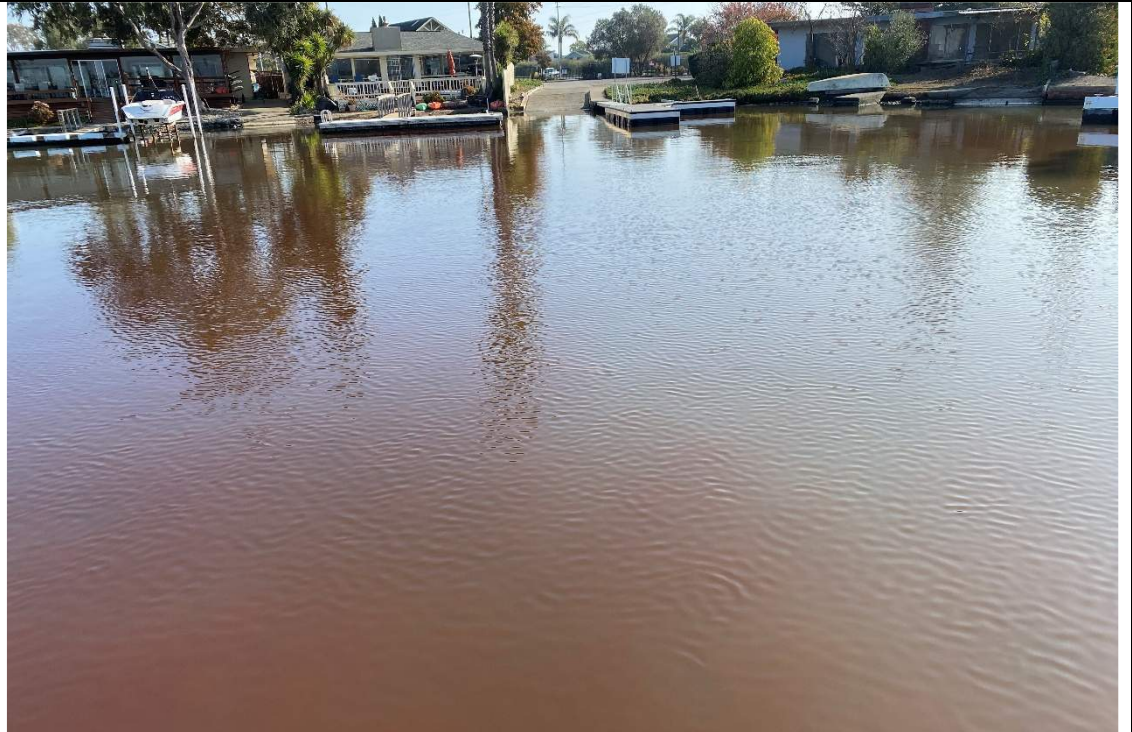
Photo No. 5	Date: 12/04/2020
Direction Photo Taken: Southeast	
Photo Taken By: A. Cormier	
Description: North Lagoon Calypso Shores Boat Ramp Area.

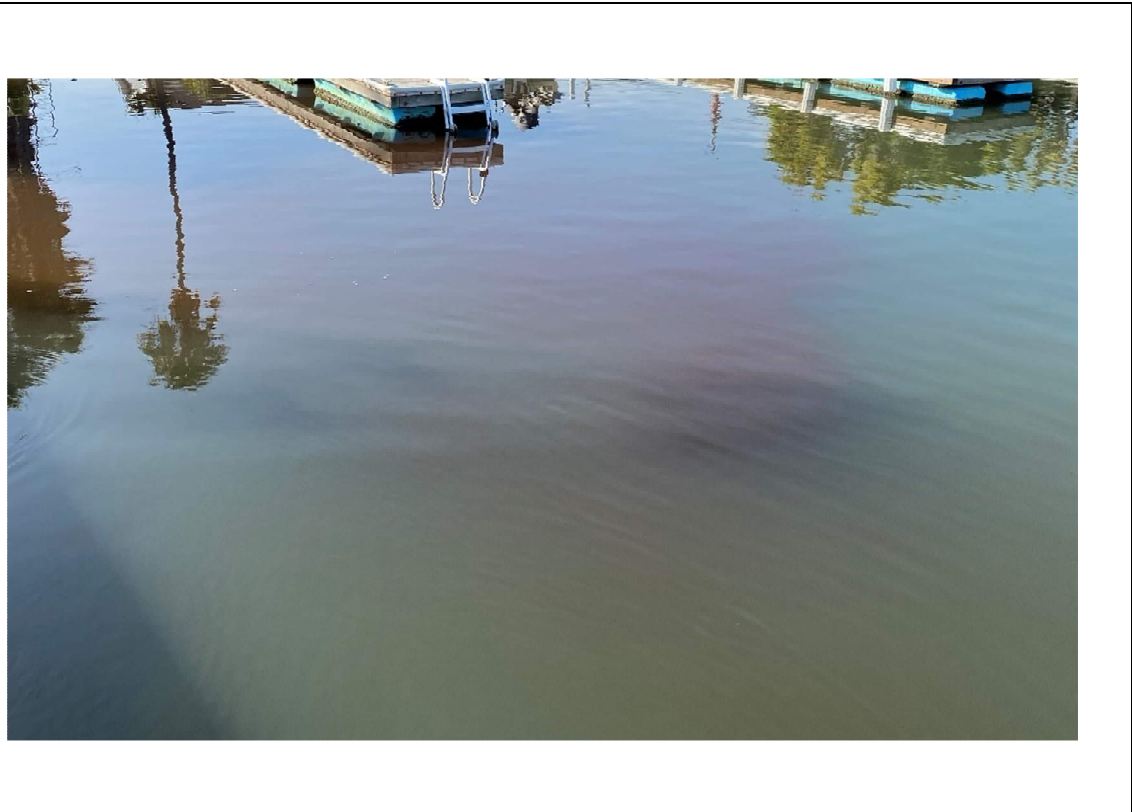
Photo No. 6	Date: 12/04/2020
Direction Photo Taken: N/A	
Photo Taken By: A. Cormier	
Description: North Lagoon on the east side of Caribe.

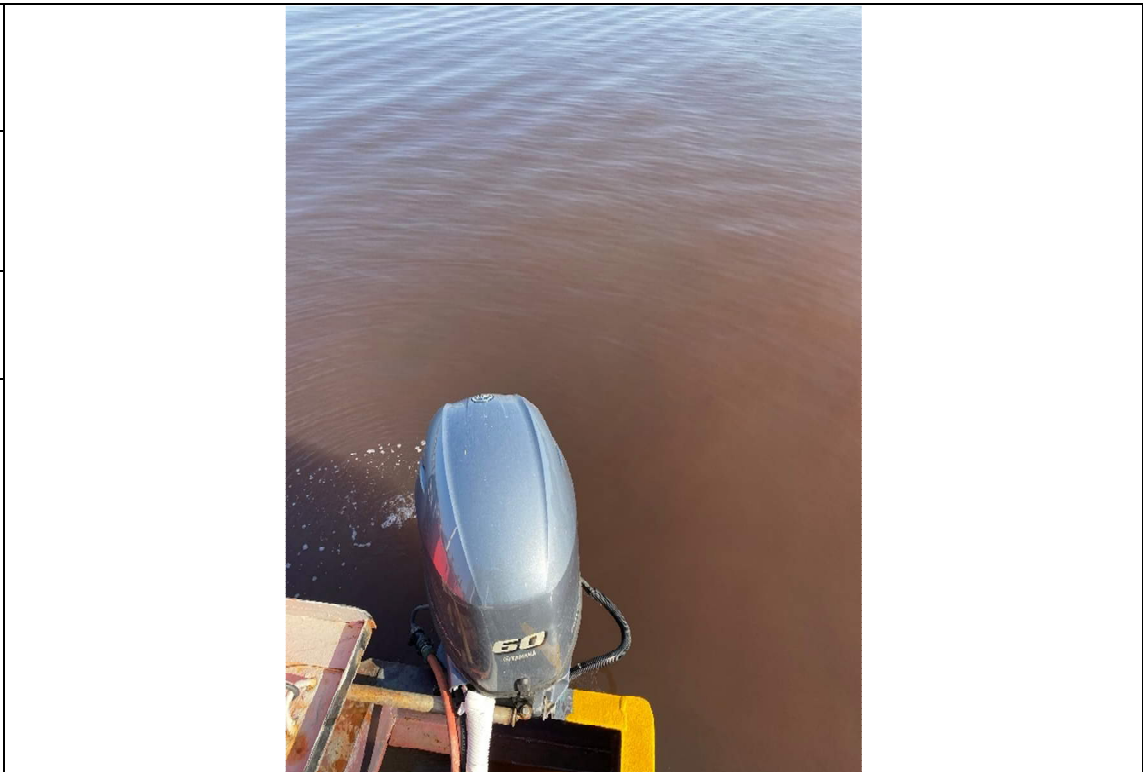
Photo No. 7	Date: 12/04/2020
Direction Photo Taken: N/A	
Photo Taken By: A. Cormier	
Description: North Lagoon southeast side of Caribe.

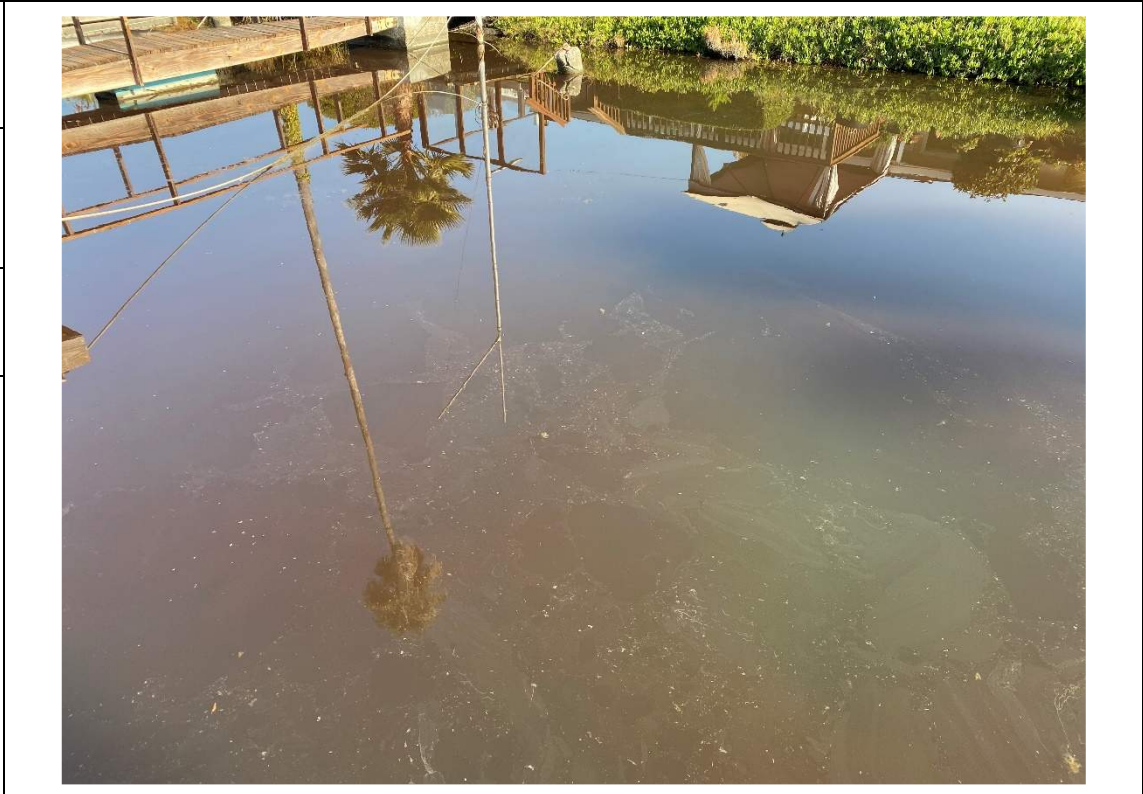
Photo No. 8	Date: 12/04/2020
Direction Photo Taken: N/A	
Photo Taken By: A. Cormier	
Description: North Lagoon just west of the Gardens Dock.

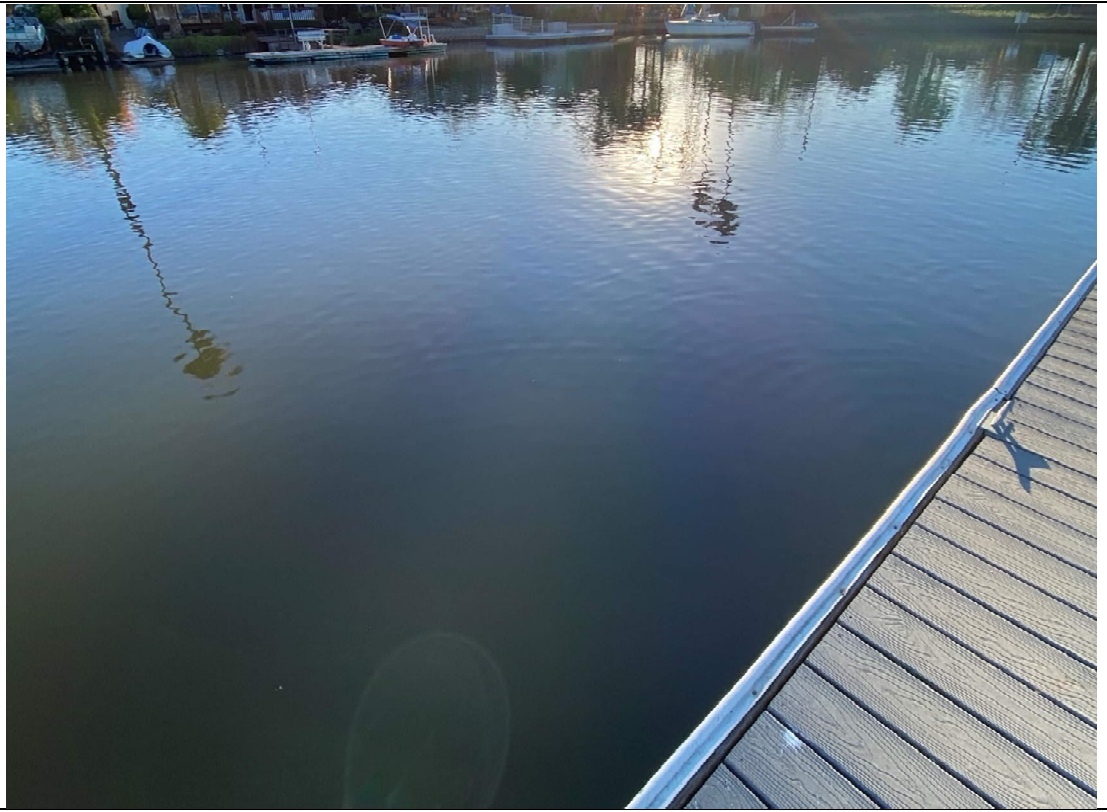
Photo No. 9	Date: 12/07/2020
Direction Photo Taken: Southeast	
Photo Taken By: A. Cormier	
Description: North Lagoon: Garden Dock Area.

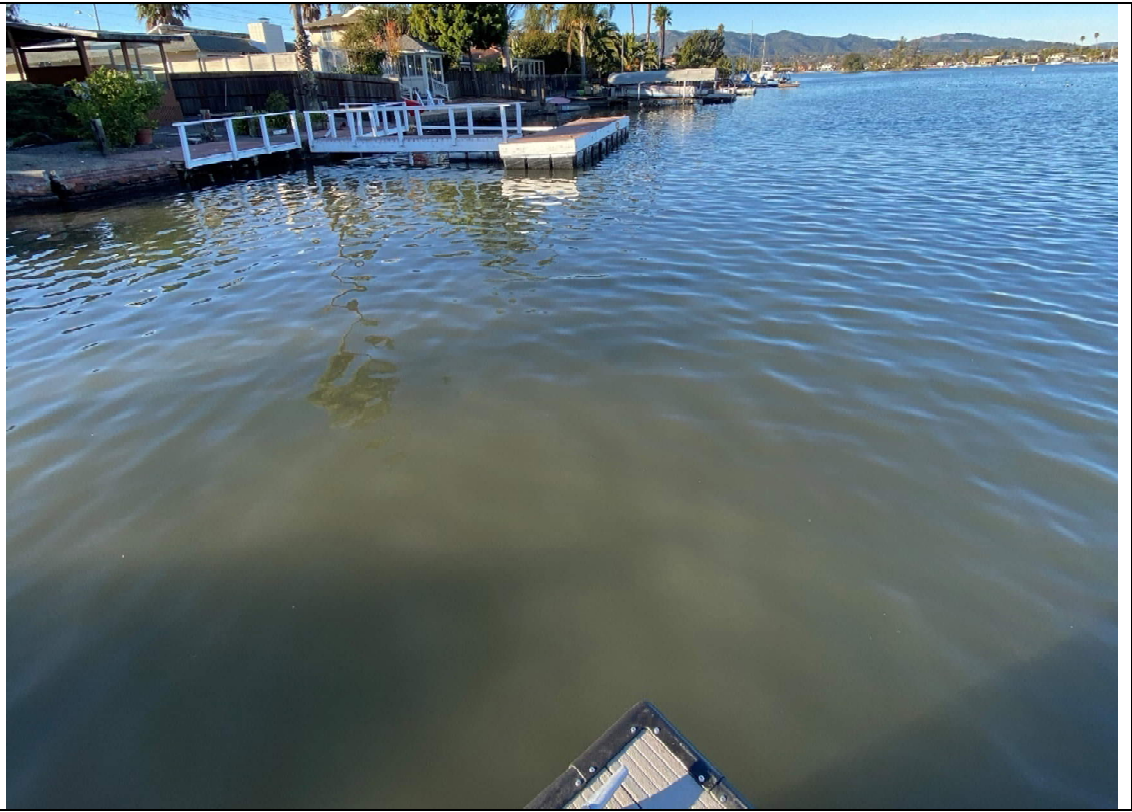
Additional observations of the algae indicated it was turning from a red to a cloudy green coloration where it was initially observed while other areas still appeared to be more red in color. The algae was also noticed to be changing locations depending on the prevailing wind direction.

Photo No. 10	Date: 12/07/2020
Direction Photo Taken: N/A	
Photo Taken By: A. Cormier	
Description: North Lagoon: Calypso Shores Boat Ramp Area. Algae is turning a more green color and less red.

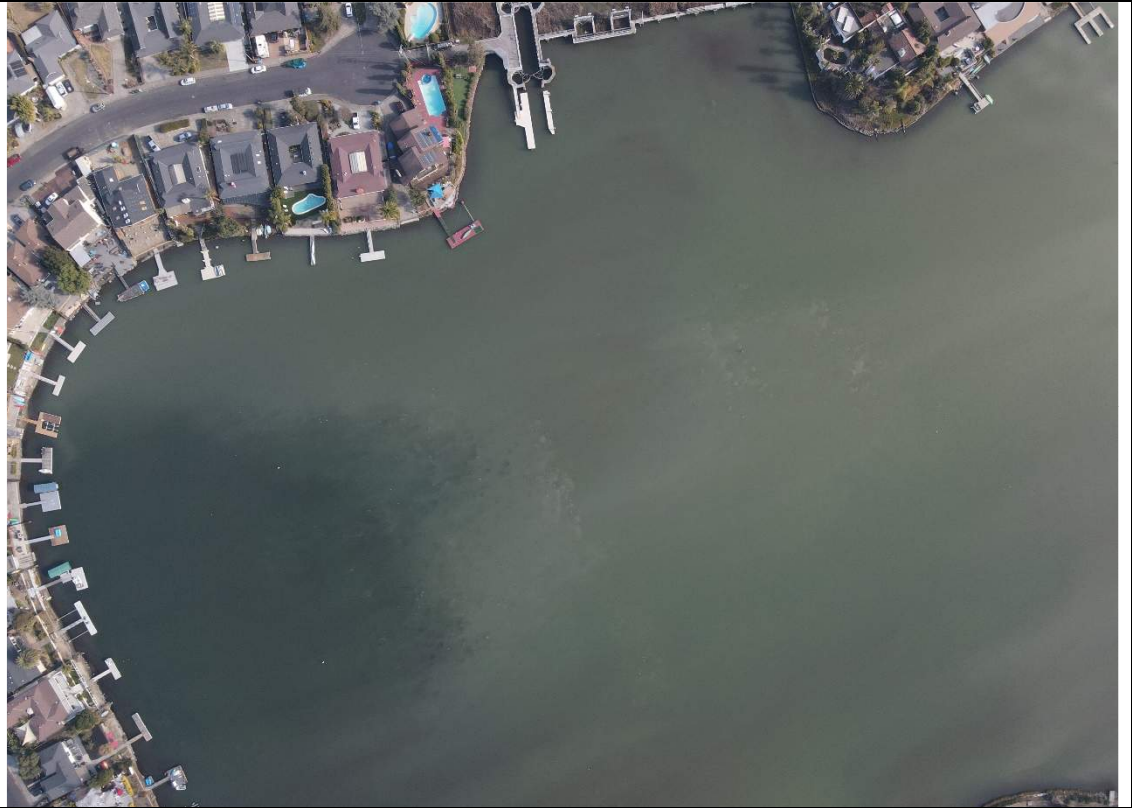
Photo No. 11	Date: 12/09/2020
Direction Photo Taken: N/A	
Photo Taken By: Others	
Description: North Lagoon: Aerial view of the 200 block area of Montego Key.

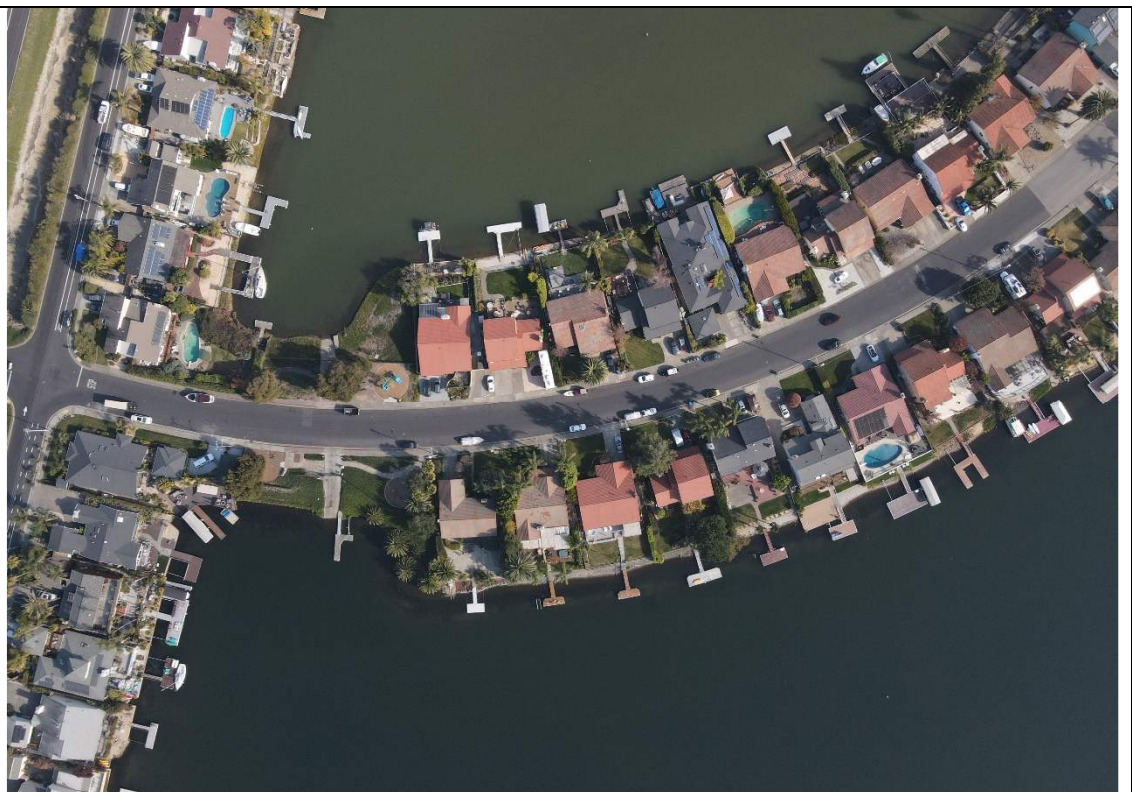
Photo No. 12	Date: 12/09/2020
Direction Photo Taken: N/A	
Photo Taken By: Others	
Description: South Lagoon: Aerial view of Bahama Reef Boat Ramps.

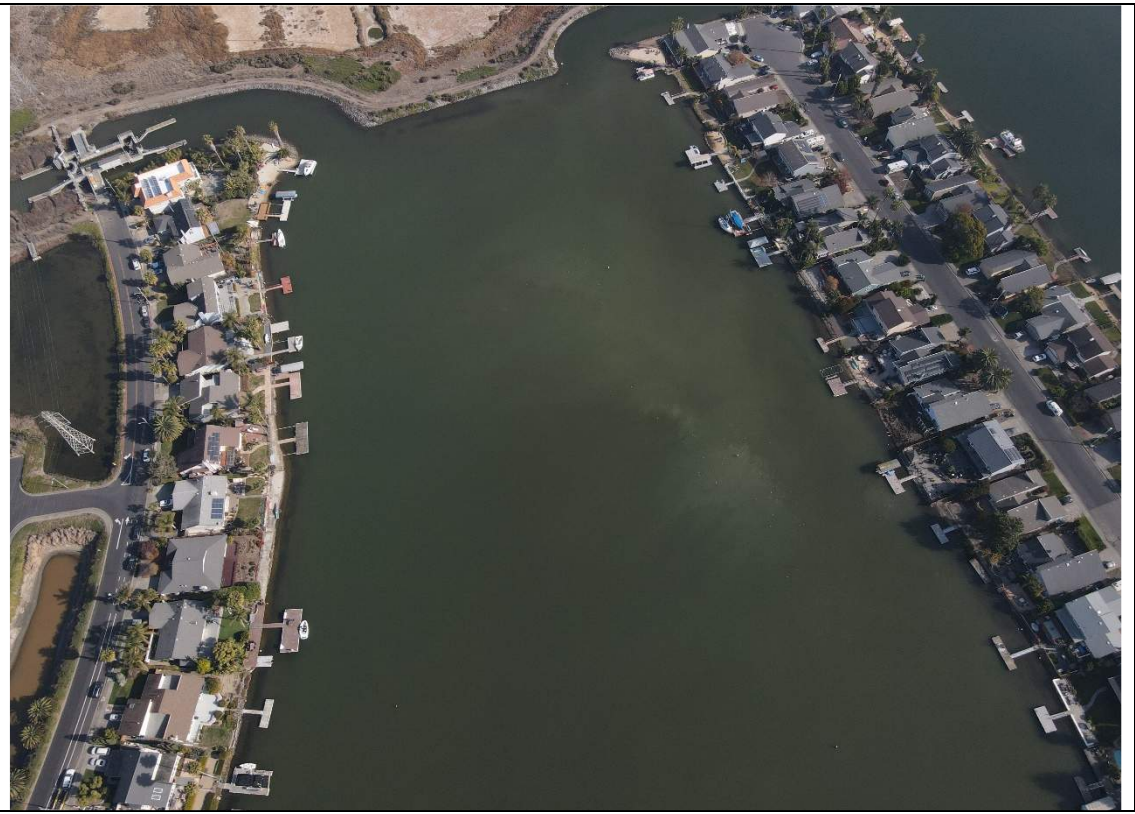
Photo No. 13	Date: 12/09/2020
Direction Photo Taken: N/A	
Photo Taken By: Others	
Description: South Lagoon: Aerial view of sunrise lagoon / end of BMK Blvd. and Bahama Reef.

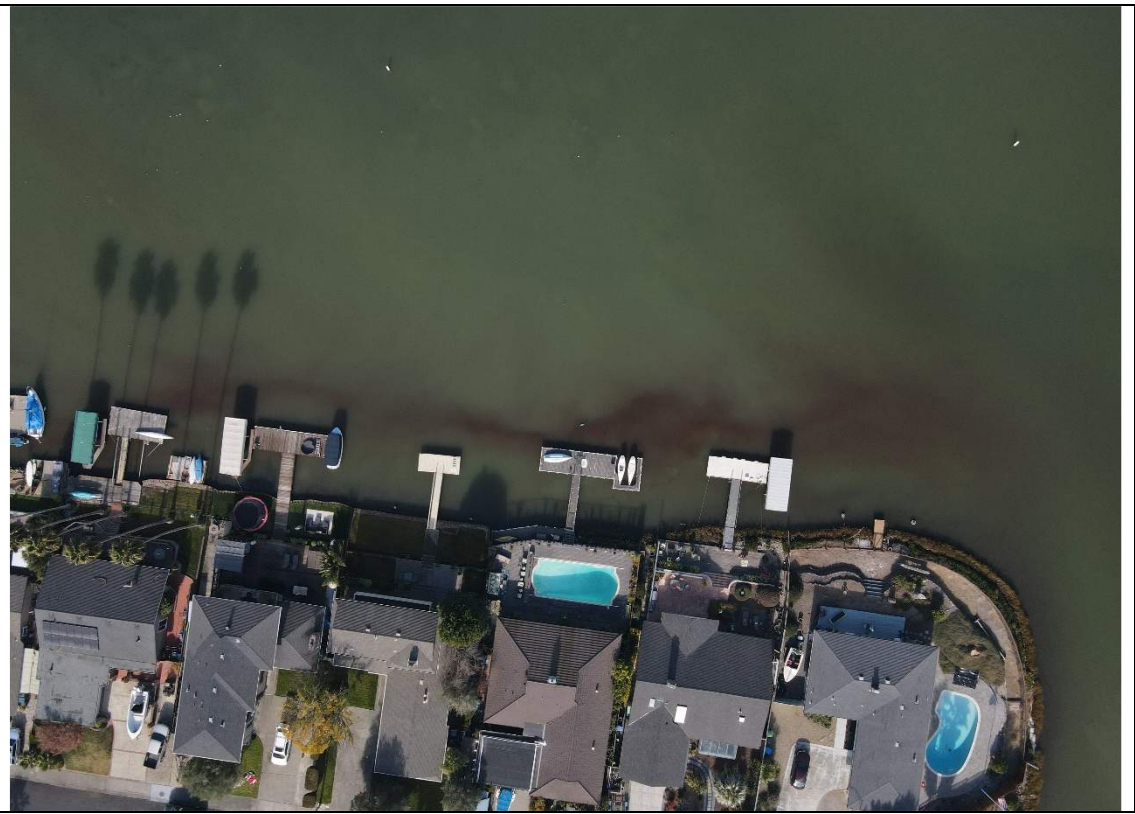
Photo No. 14	Date: 12/09/2020
Direction Photo Taken: N/A	
Photo Taken By: Others	
Description: North Lagoon: Aerial view of the northern side at the end of Caribe.

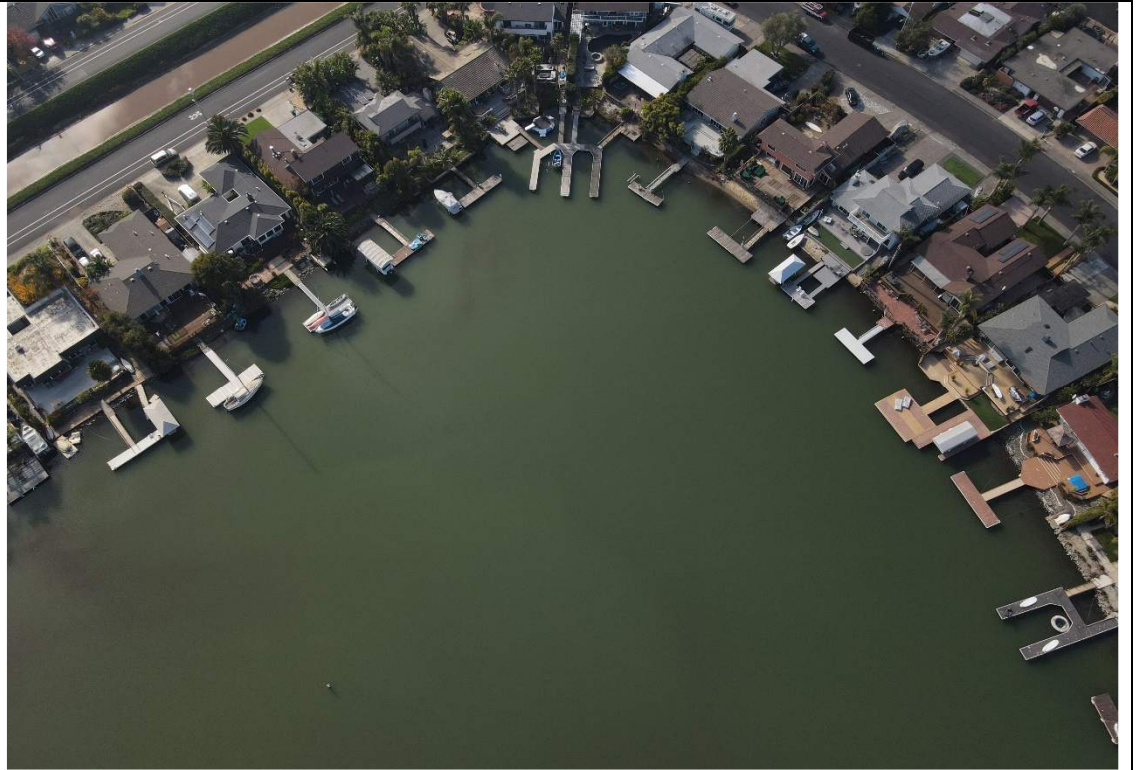
Photo No. 15	Date: 12/09/2020
Direction Photo Taken: N/A	
Photo Taken By: Others	
Description: North Lagoon: Aerial view of the intersection of Caribe and BMK Blvd.

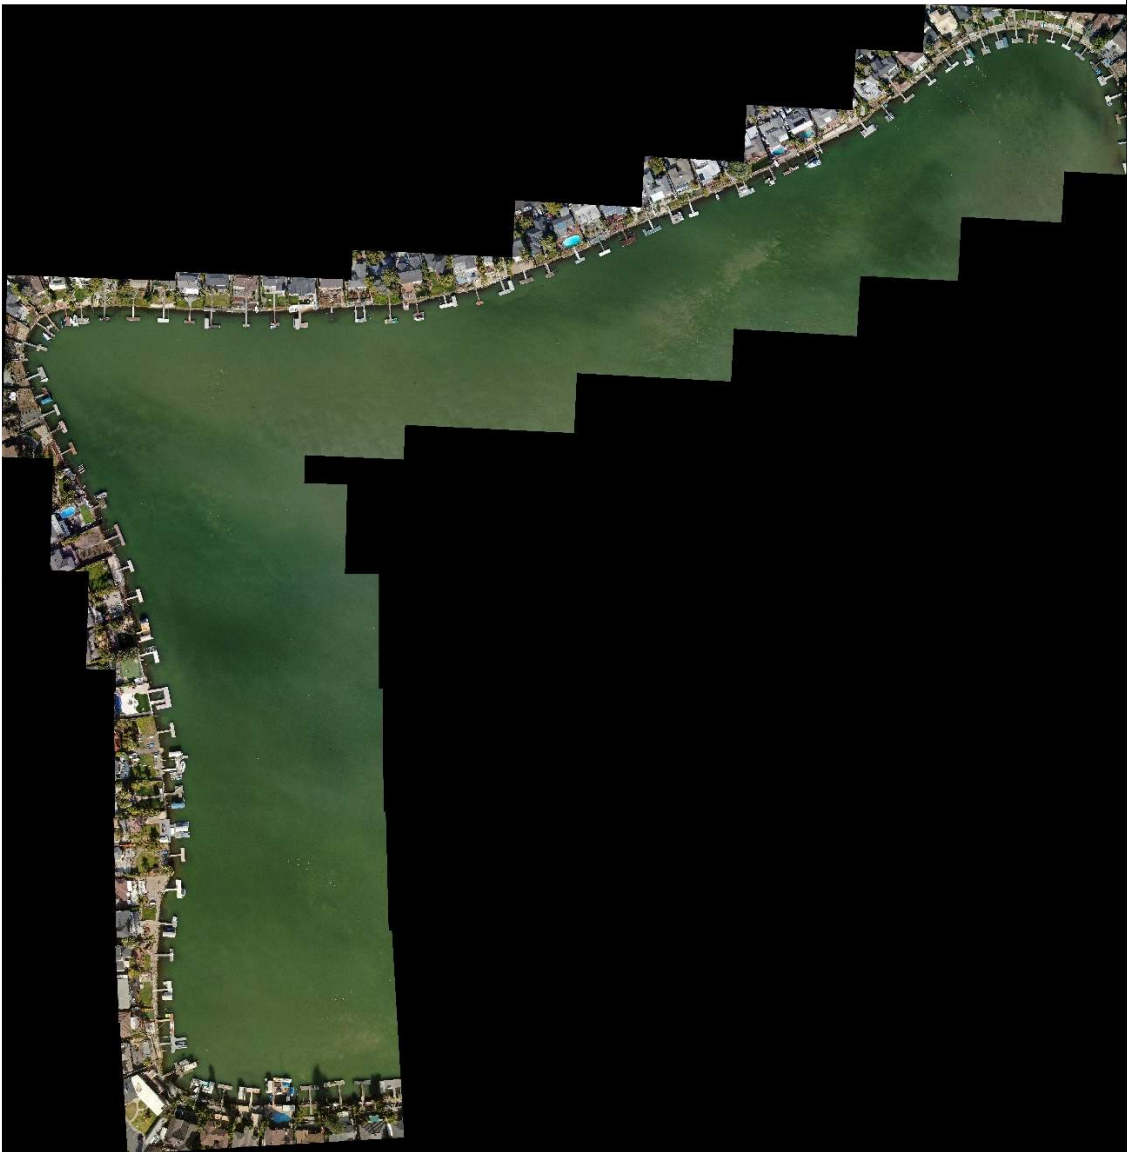
Photo No. 16	Date: 12/15/2020
Direction Photo Taken: Right-click here	
Photo Taken By: Others	
Description: North Lagoon: Aerial stitched photos along Montego Key.

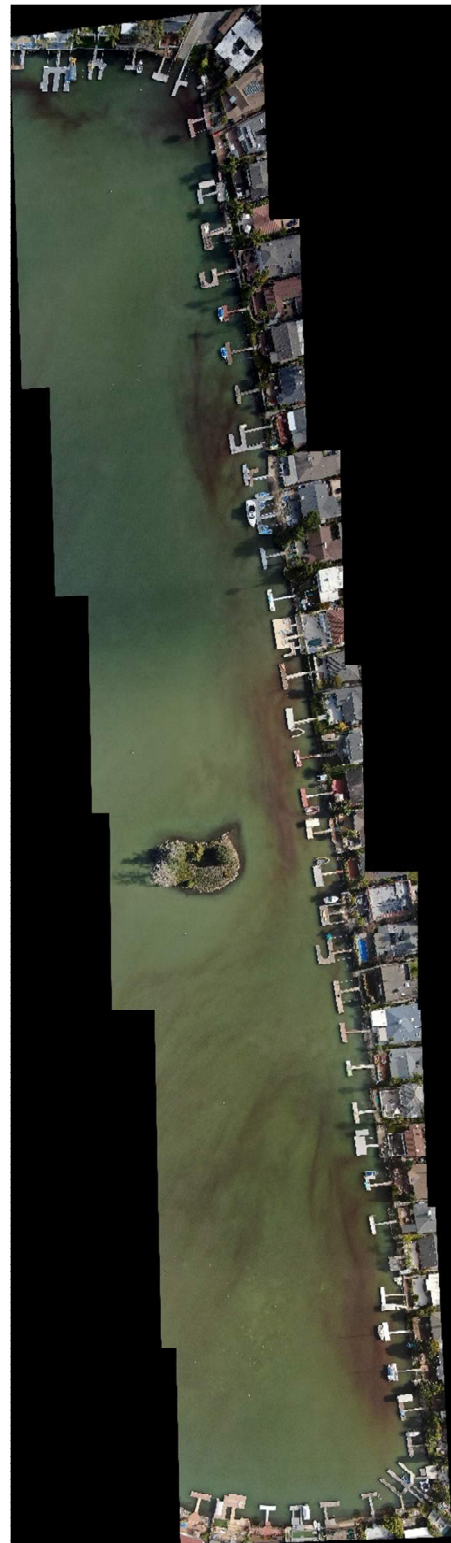
Photo No. 17	Date: 12/15/2020
------------------------	----------------------------

Description:
 North Lagoon: Aerial stitched photos between Caribe and Calypso Shores.

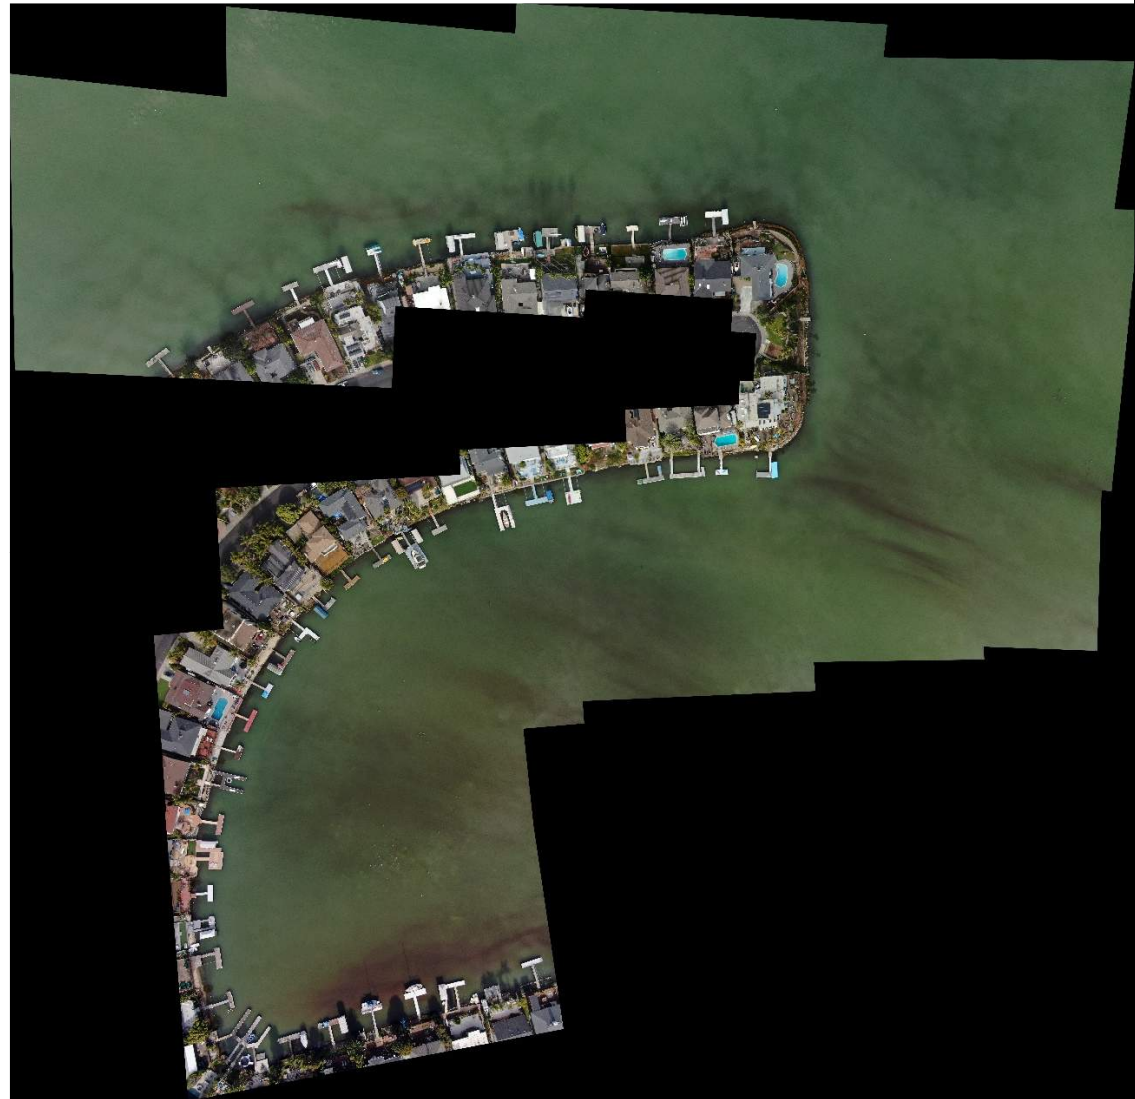
Photo No. 18	Date: 12/15/2020
-------------------------------	----------------------------

Description:
North Lagoon: Aerial stitched photos of Caribe. North is up.

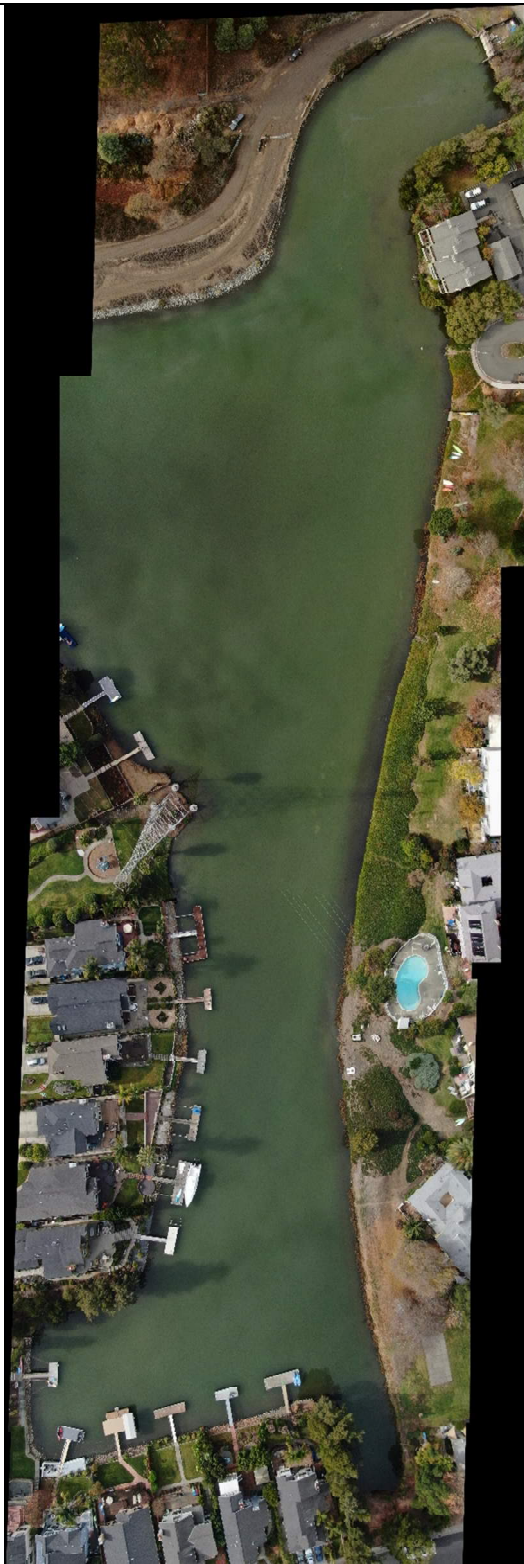
Photo No. 19	Date: 12/15/2020
------------------------	----------------------------

Description:
 South Lagoon: Aerial stitched photos of the culvert gates / Gardens / north side of Cavalla Cay.

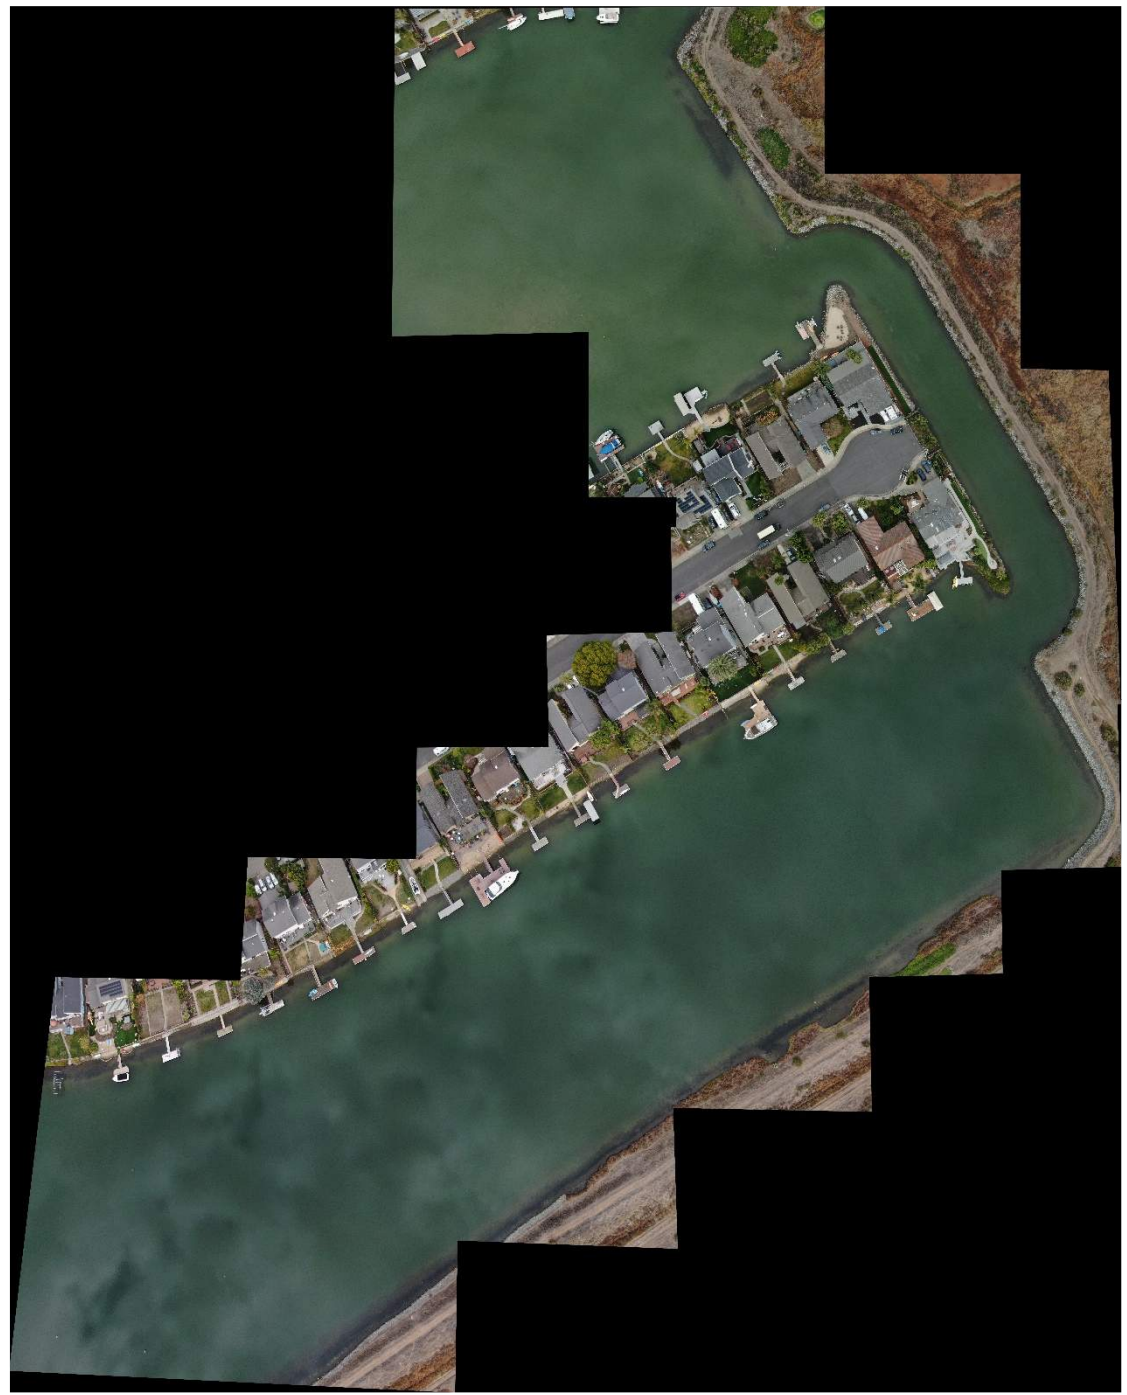
Photo No. 20	Date: 12/15/2020
------------------------	----------------------------

Description:
 South Lagoon: Aerial stitched photos of the end of Bahama Reef

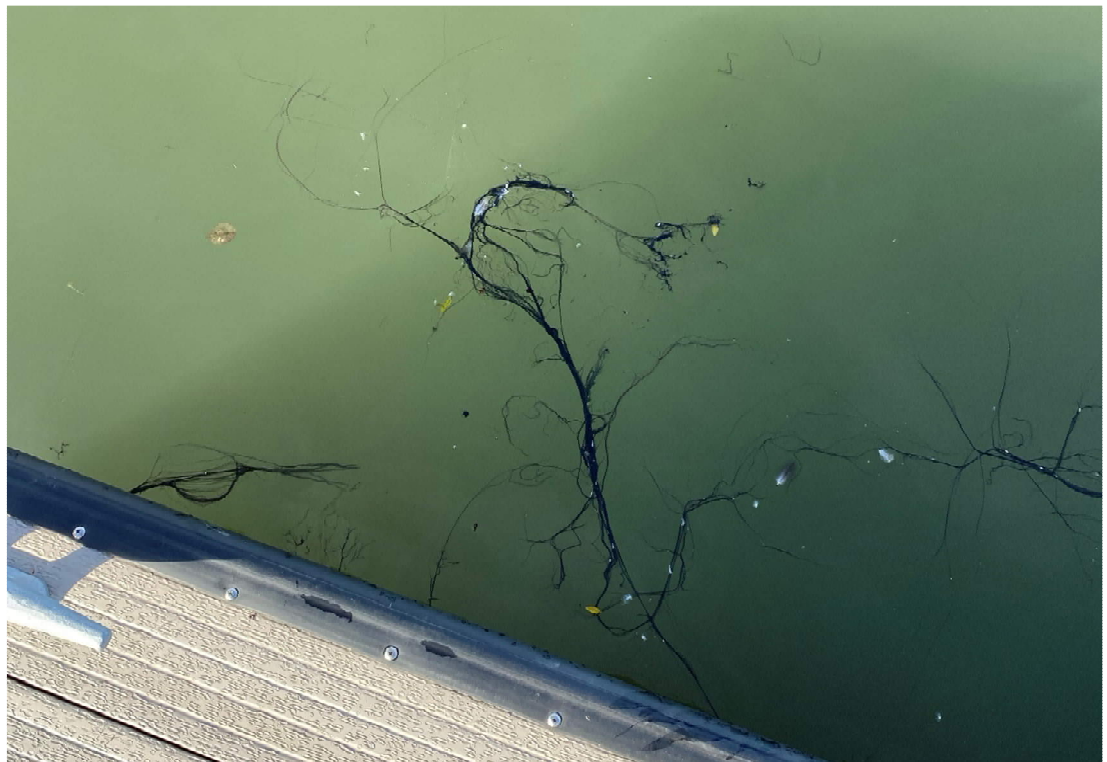
Photo No. 21	Date: 12/28/2020
Direction Photo Taken: N/A	
Photo Taken By: A. Cormier	
Description: North Lagoon: Calypso Shores Boat Ramp

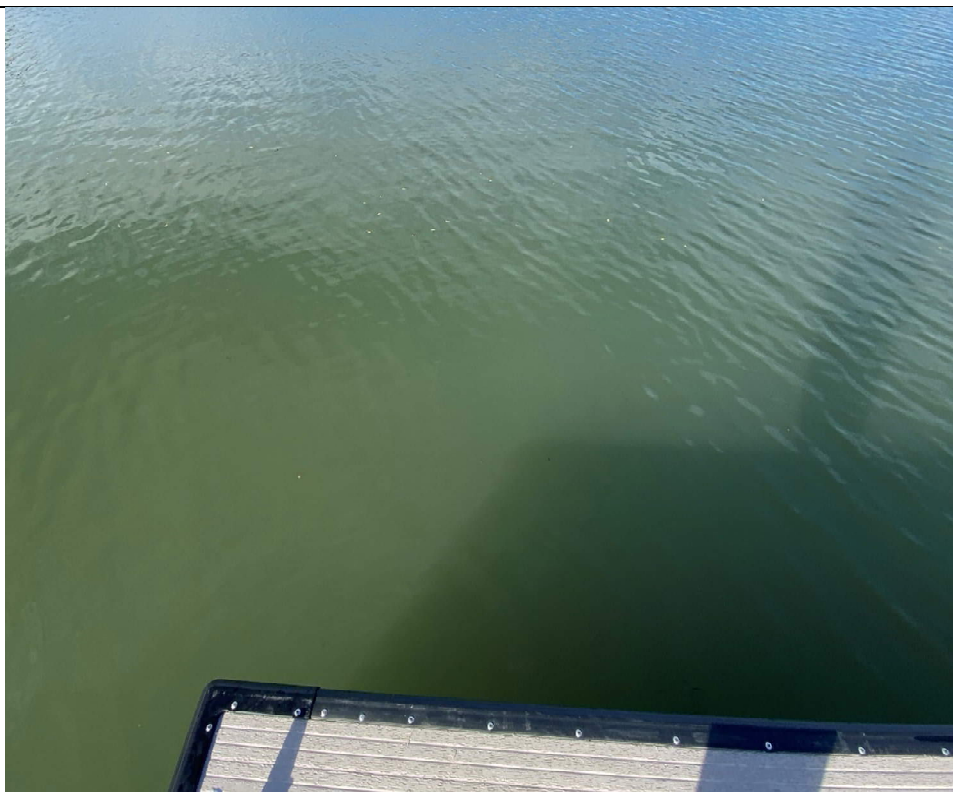
Photo No. 22	Date: 12/28/2020
Direction Photo Taken: N/A	
Photo Taken By: A. Cormier	
Description: North Lagoon: Calypso Shores Boat Ramp

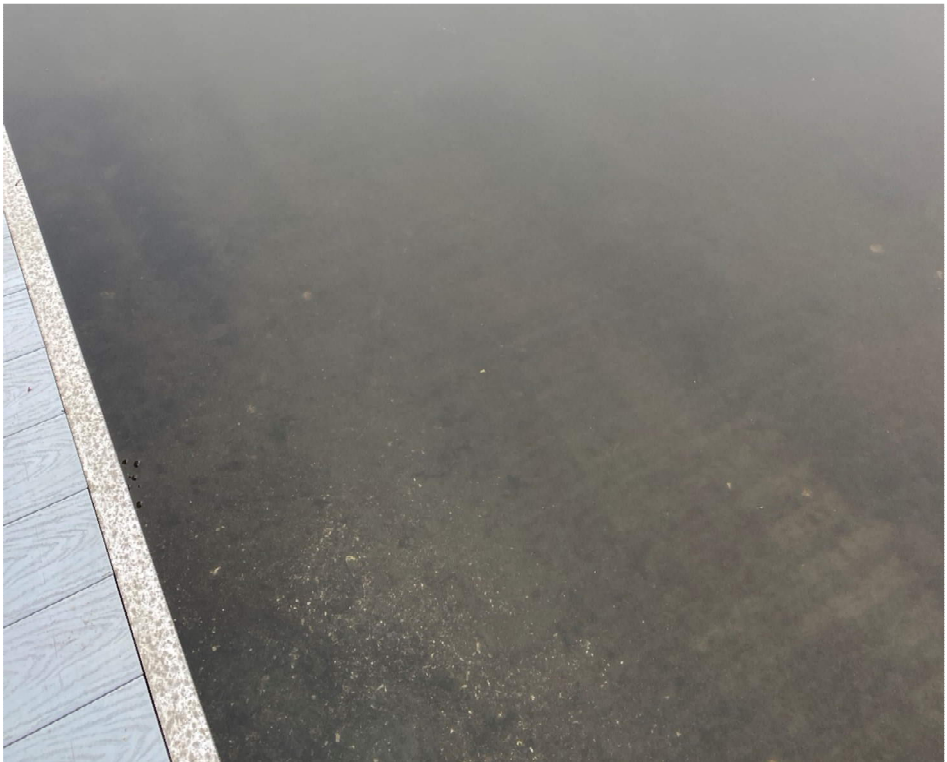
There have been no new observations of any red-colored algae in either the North or South Lagoons, however there remains areas of cloudy green-colored algae in both lagoons. The areas in which observations are made vary as winds and weather patterns change. Foth has continued our routine monitoring of the water quality in both lagoons with testing for Dissolved Oxygen (DO), pH, and salinity; all of which have fallen within the normal parameters. Foth has added additional sampling locations out of an abundance of caution which has resulted in no noticeable evidence of oxygen reduction. Following the guidance from the industry experts at WHOI Foth and e limnology have not collected any further physical samples of the algae for testing, however if new areas of red-colored algae return samples will be collected and analyzed again with the additional protocols outlined by WHOI to ensure preservation and integrity of the samples. There also continues to be no reports of unusual wildlife behavior such as dead fish or disturbed waterfowl.

Photo No. 23	Date: 01/09/2021
Direction Photo Taken: N/A	
Photo Taken By: A. Cormier	
Description: North Lagoon: Calypso Shores Boat Ramp
