RE: Update on Algae Presence in North and South Lagoons

Exhibit A – Photo Log of Algae in North and South Lagoons

Client's Name: Bel Marin Keys Community Services District	Site Location: BMKCSD: North and South Lagoons	Project No. 0020B046.00
---	--	-----------------------------------

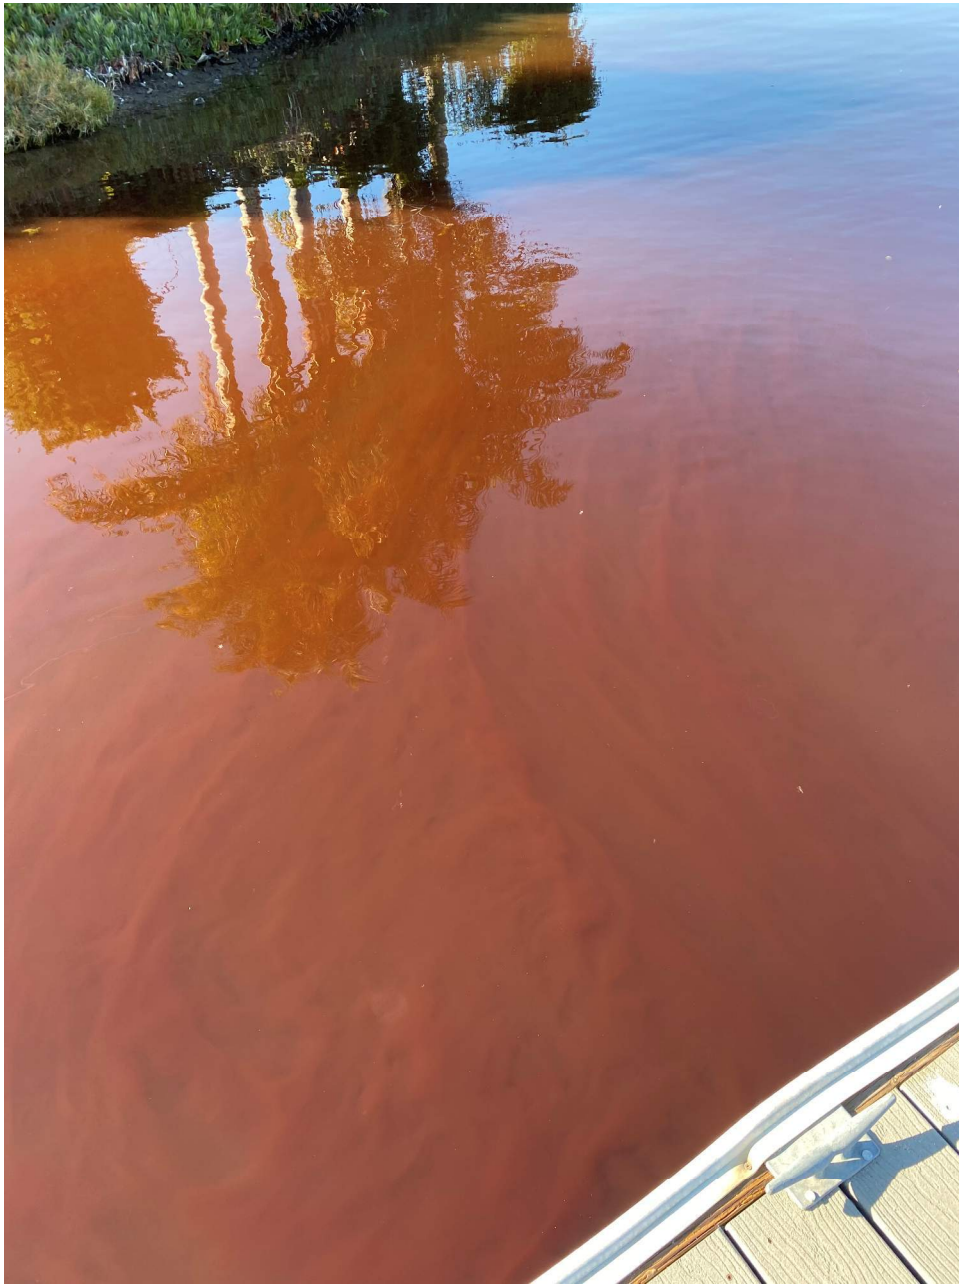
Photo 1: Photo taken on 11/30/2020 in the North Lagoon

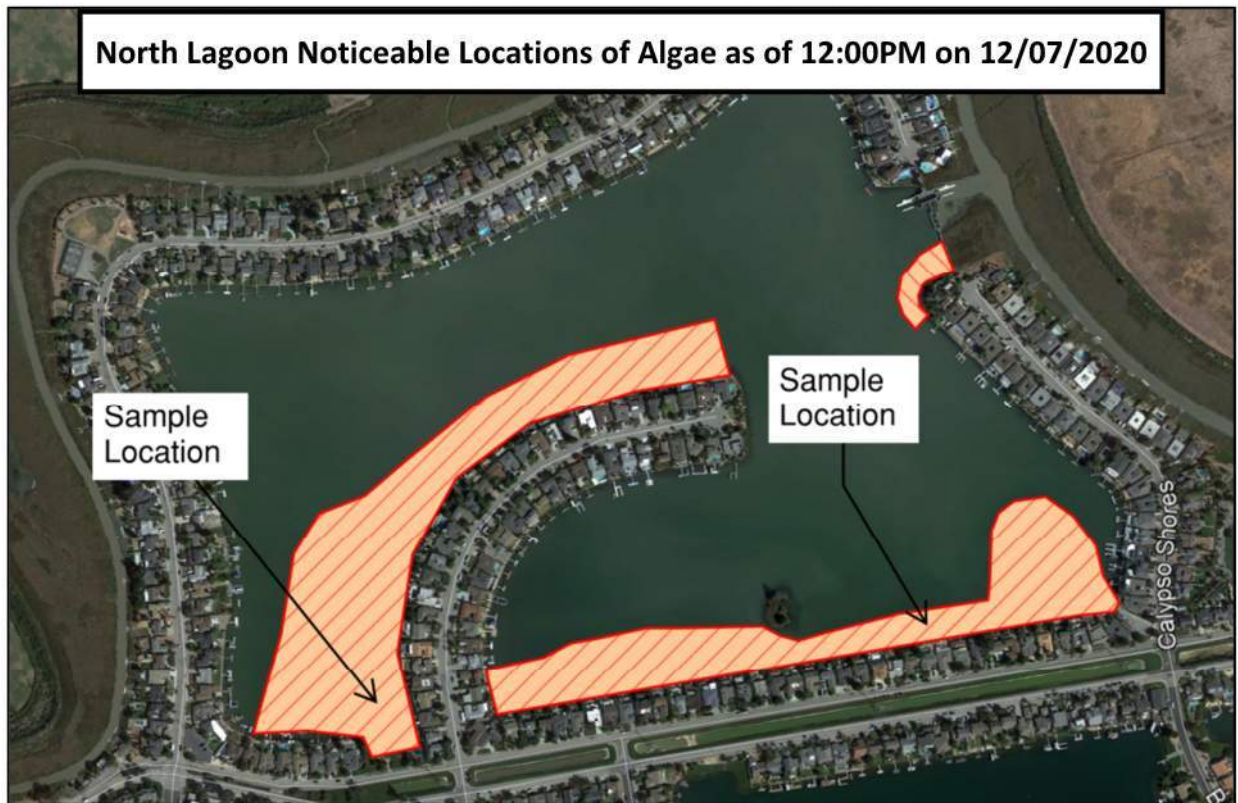
North Lagoon Noticeable Locations of Algae as of 12:00PM on 12/07/2020

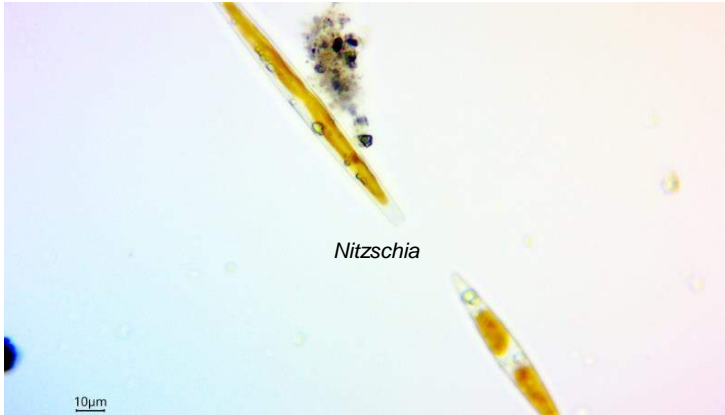
Sample ID	Dominant	Sub-dominant	Also present	Notes
NL CSBR	NA			No cyanobacteria were observed in this sample. However, there was a variety of other eukaryotic phytoplankton, including the diatom <i>Nitzschia</i> sp., an unidentified cryptomonad, and what appears to be a picoeukaryote chlorophyte (<i>Ostreococcus</i>). The photomicrographs were all taken under 400X magnification.

<p><i>Nitzschia</i></p> <p>10µm</p>

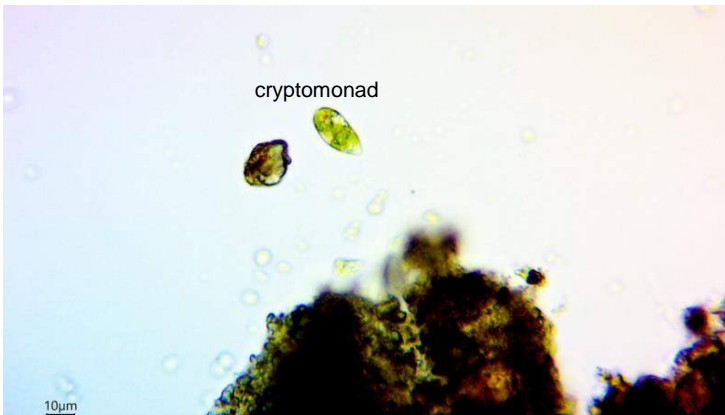
<p>cryptomonad</p> <p>10µm</p>

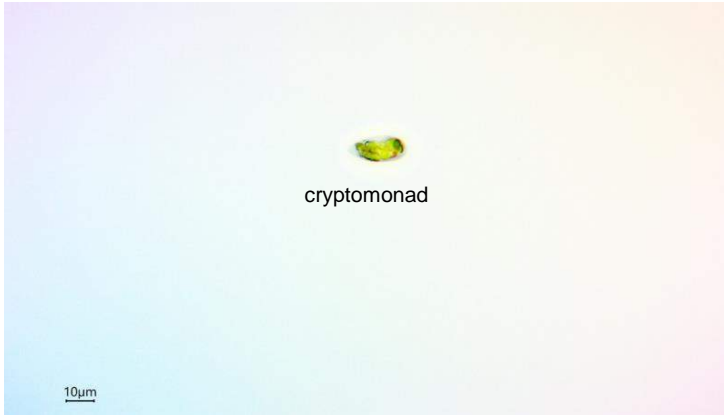
Sample ID	Dominant	Sub-dominant	Also present	Notes
SL Sunrise	NA			No cyanobacteria were observed in this sample. Instead, there was a low amount of cryptomonads, diatoms (including <i>Gyrosigma</i>) and only a low amount of the picoeukaryote believed to be <i>Ostreococcus</i> . All photomicrographs were taken under 400X magnification. Overall, this sample contained significantly less algae than the North Lagoon sample.

<p>cryptomonad</p> <p>10µm</p>

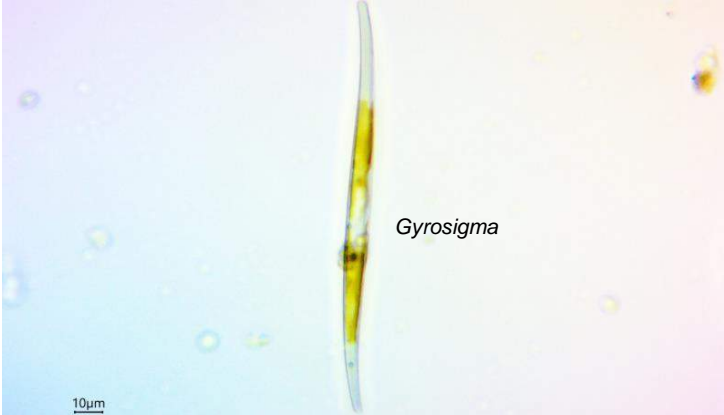
<p><i>Gyrosigma</i></p> <p>10µm</p>

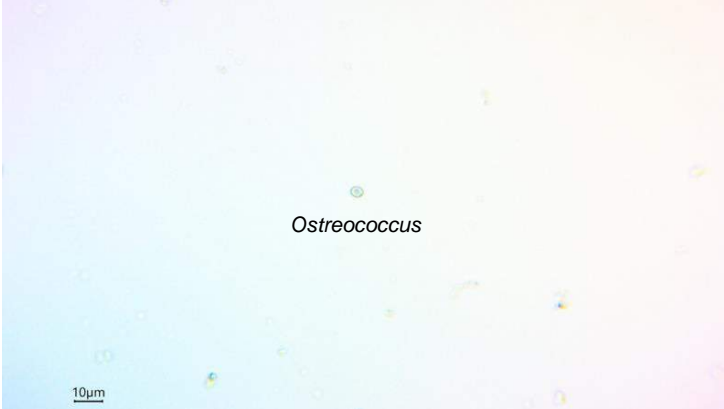
<p><i>Ostreococcus</i></p> <p>10µm</p>
